SOMETHING OLD, SOMETHING NEW ...

A new twist on a proven trenchless rehabilitation technology shows promise for resolving a California water company's steel pipe replacement issues

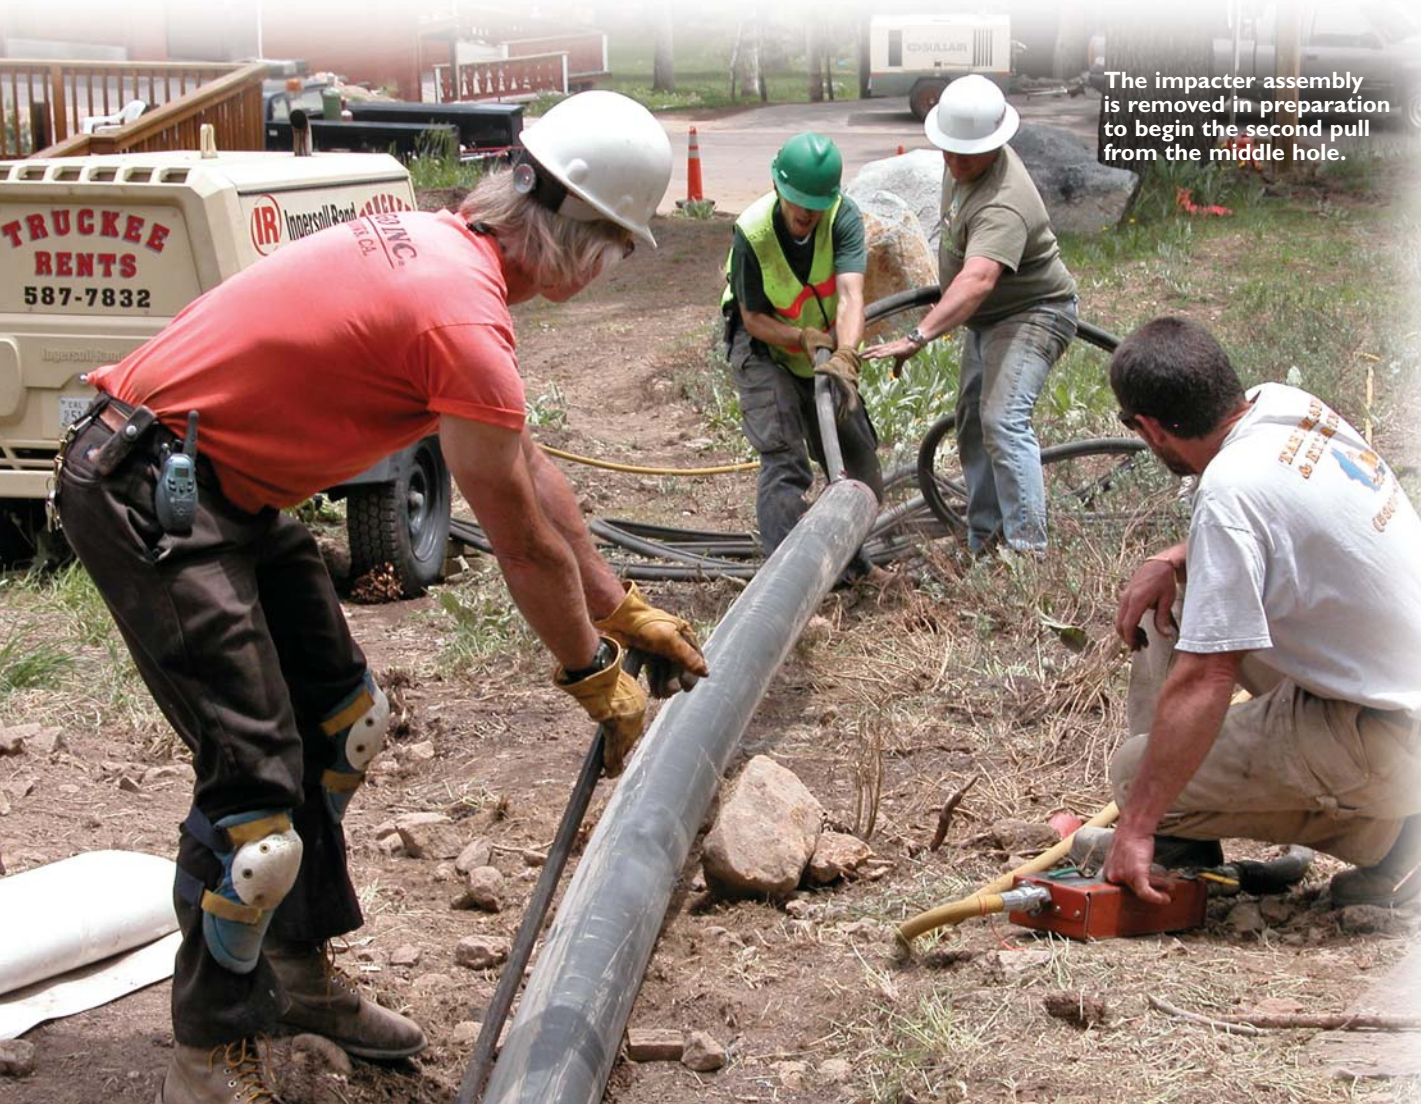
The impacter assembly is removed in preparation to begin the second pull from the middle hole.

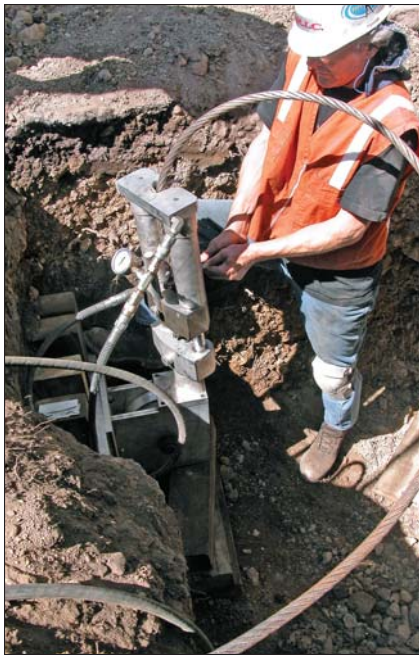
Worn grippers require assistance for entire pull.

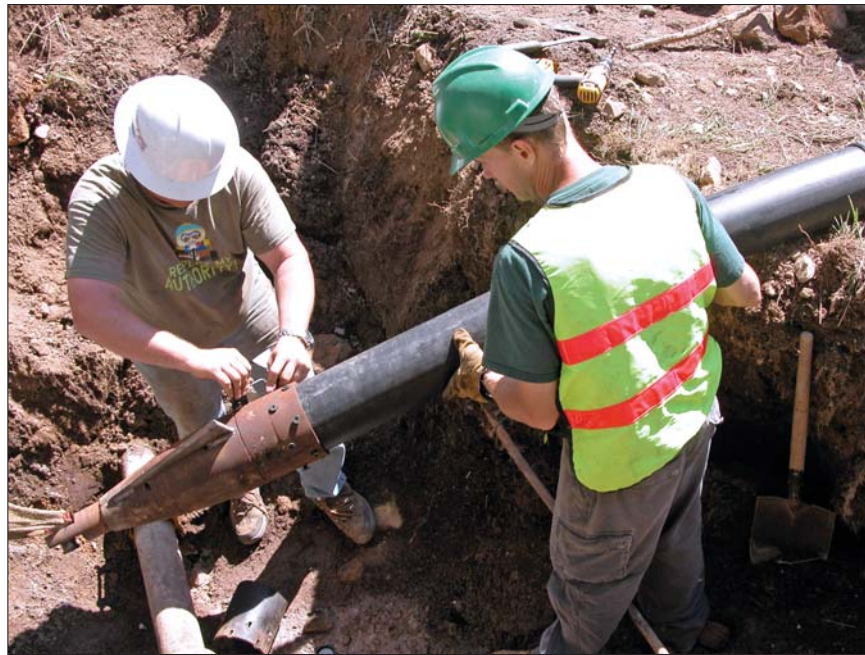
Final adjustments are made to the pipe attachment.

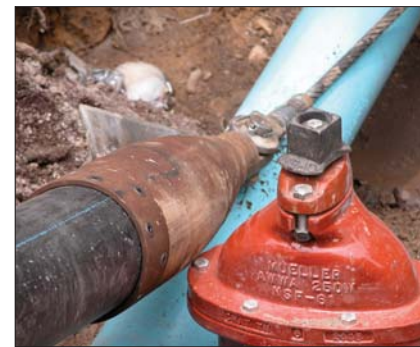
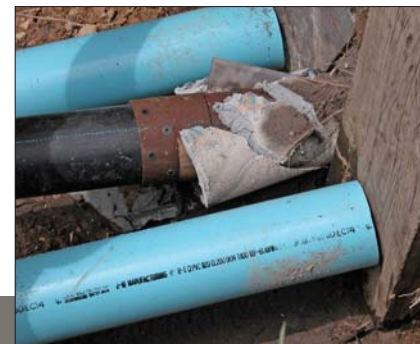
Upper right, easing the bursting head into the entrance pit. Lower right, the bursting head enters the asbestos cement pipe and is pulled by the hydraulic ram in the exit pit.

The TRIC crew completed the two sections of bursting and replacement using the same family of high-pressure equipment as for the smaller steel line project, but with a push-pull method, combining static and impact forces to propel the bursting head through the existing pipe.

Static force applies tension to the cable pulling the bursting head from the front. Impact force helps the head along by acting as a small jackhammer, beating from behind the head and using built-up cable tension to propel the head more effectively than by either method alone. The push-pull method gives the bursting unit the strength to

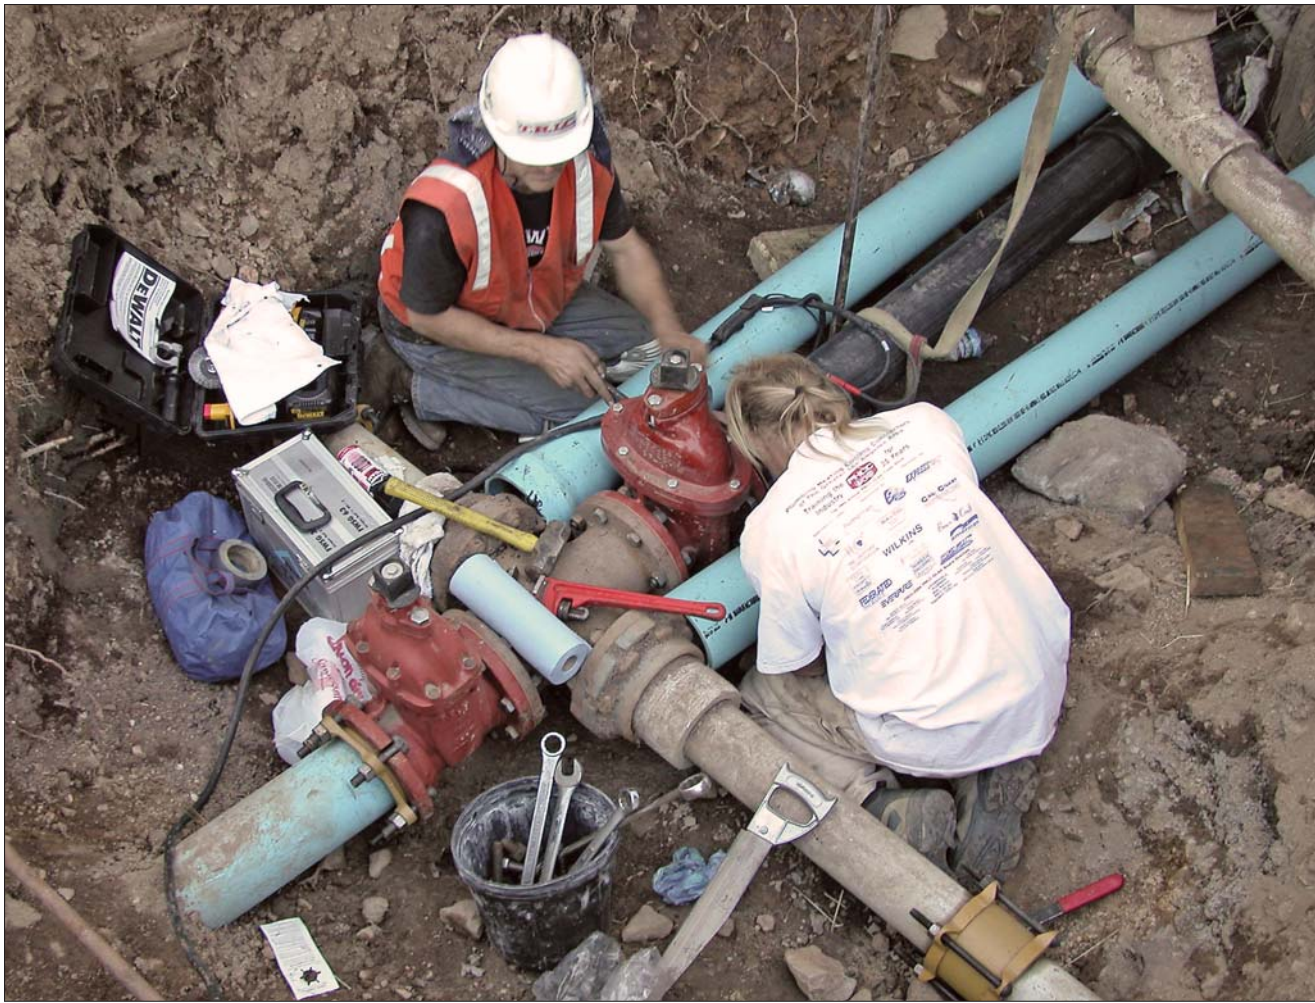
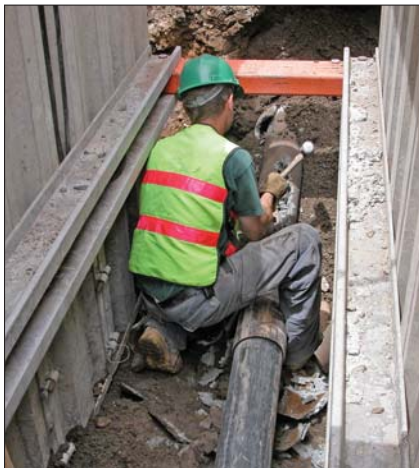
Above, the electrofusion coupling process is used to join the final joint and connect the new pipe to the valve assembly. Below, detaching the bursting head in the middle pit.

Once the two replacement sections were installed, they were tied together and put back into the system through an electrofusion coupling process specifically designed for HDPE pipe.
